RENEWWRAP®

CASE STUDY:

Greenville, SC

Column Repair

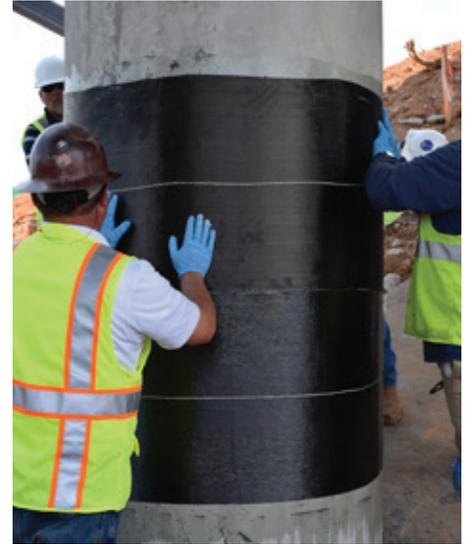
The crew wraps the column under the intersection of I-85/I-385 in South Carolina

The carbon fabric sheets were measured, cut, and stored on site until needed. The crew mixed a two-part resin and applied it to the columns using paint rollers, and then wrapped the dry carbon fiber-based fabric around the columns with the fibers aligned horizontally to provide hoop strength. A second coat of epoxy was applied to the fabric for additional strengthening, which was then followed by a second layer of the FRP material in order to ensure long-term strength.

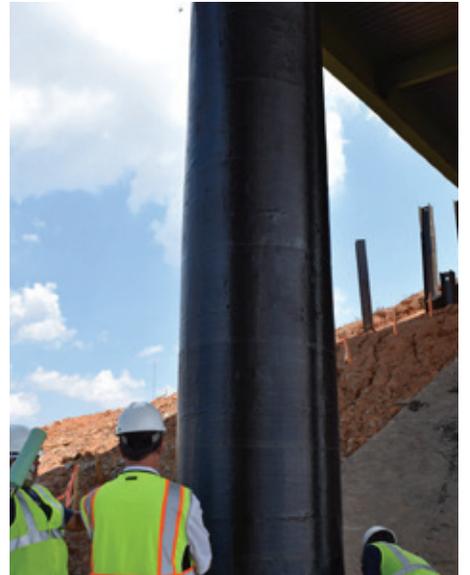
The first column was wrapped within eight hours

OCS used multiple boom lifts to give them access to the entire column surface simultaneously, speeding repair time. The first column wrap was completed in about 8 hours over a two-day period, and subsequent columns were strengthened even faster.
