USE OF UV RESISTANT PRE-SATURATED GFRP

For Protection of Wood Pilings

CASE STUDY

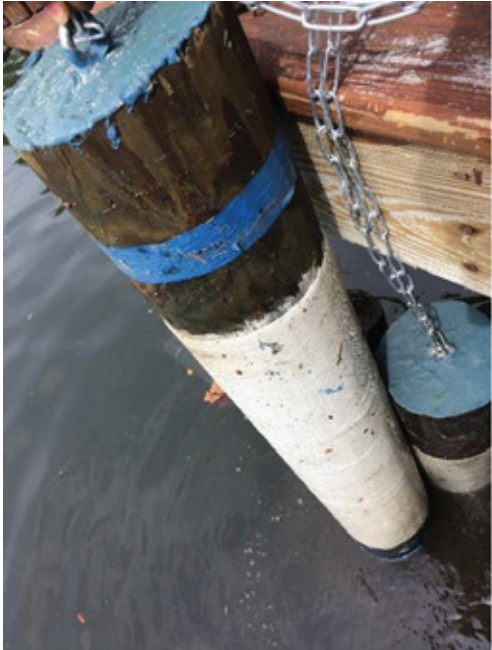
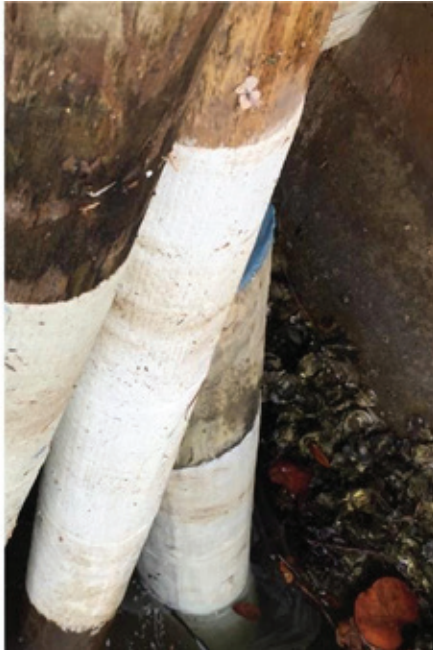
Figure 1: Conditions of the (a) treated and (b) untreated piling 3 months after submersion in the canal water

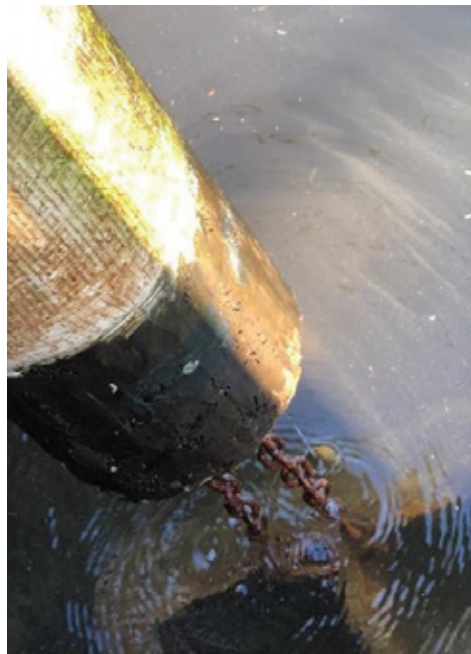
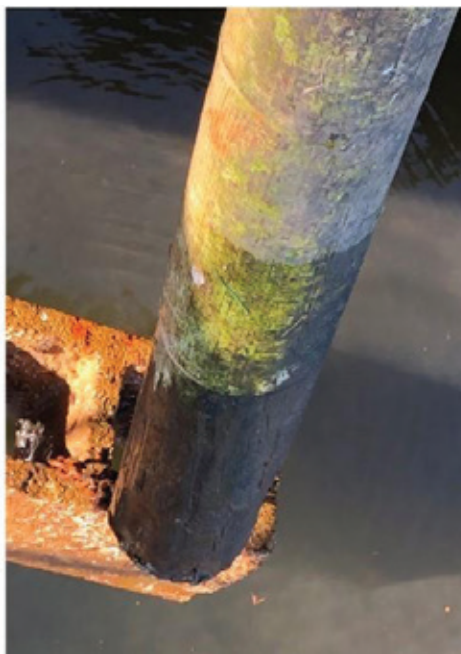
Figure 2: Conditions of the (a) treated and (b) untreated piling 1 year after submersion in the canal water

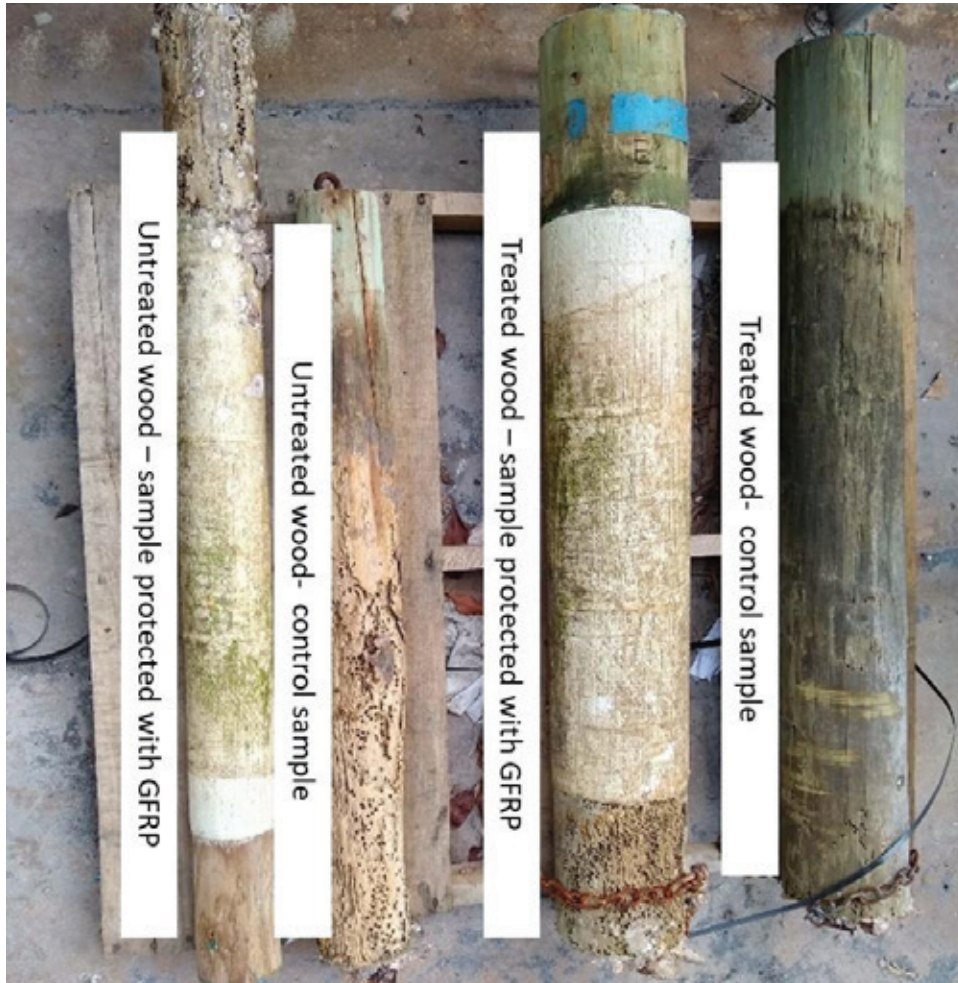
Figure 3: Conditions of the treated and untreated piling 2 years after submersion in the canal water

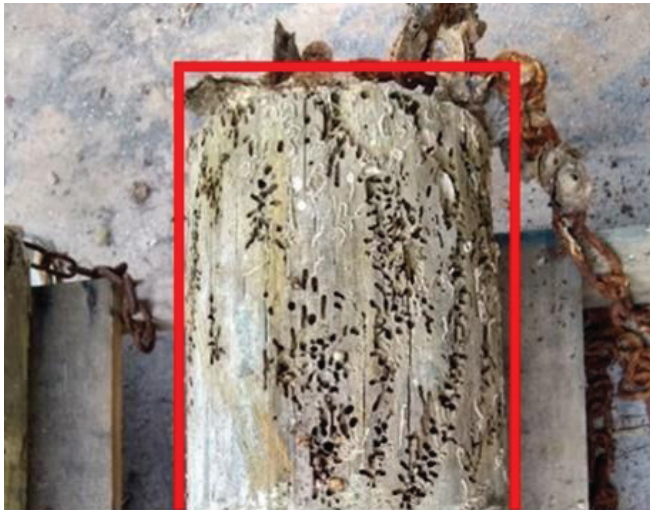
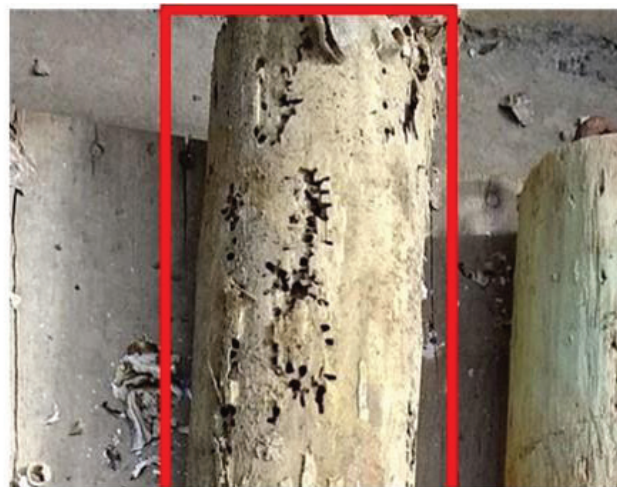
Section unprotected with GFRP

Figure 4: Conditions of the (a) treated and (b) untreated piling 2 years after submersion in the canal water and removal of the GFRP wrap, showing how well the GFRP protected the timber substrate in canal water conditions

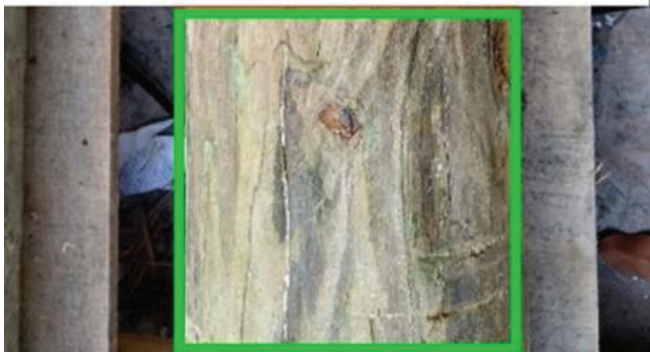
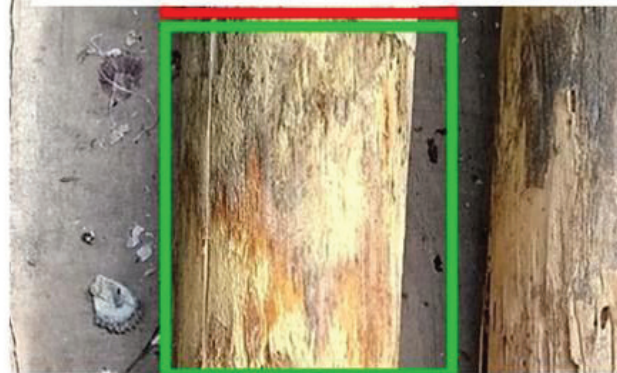
Section protected with GFRP

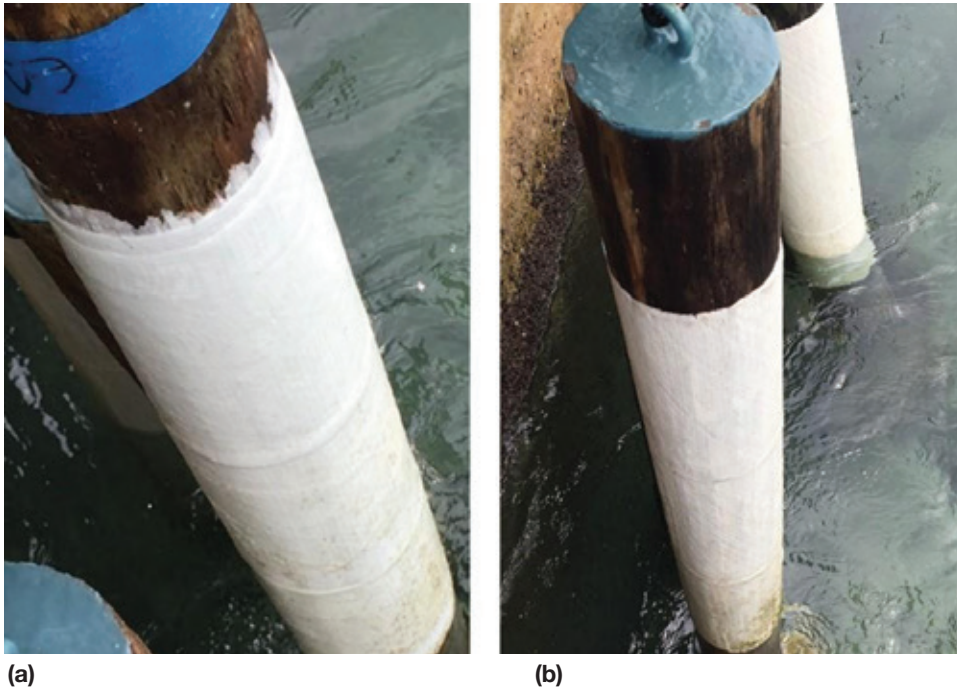
Figure 5: Conditions of the (a) treated and (b) untreated piling 3 months after submersion in the intracoastal

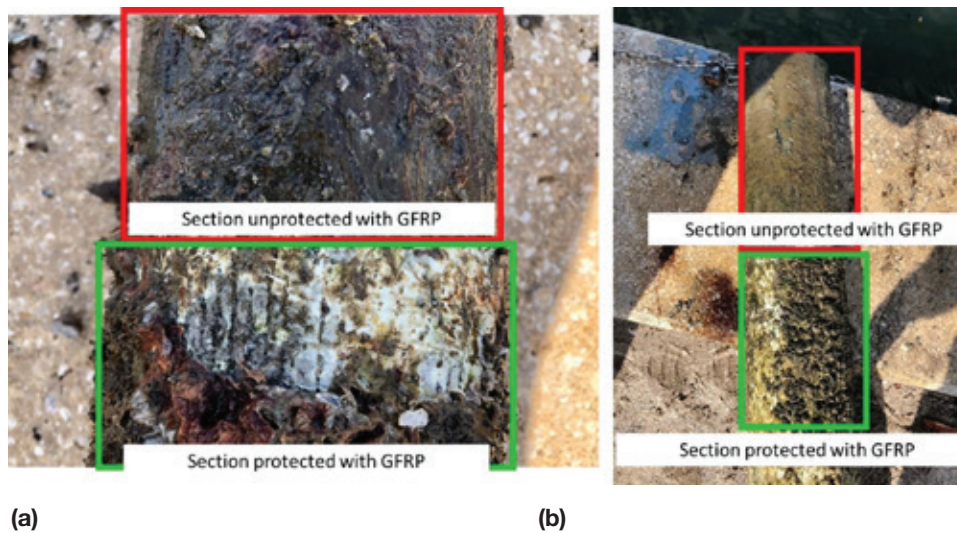
Figure 6: Conditions of the (a) treated and (b) untreated piling 1 year after submersion in the intracoastal

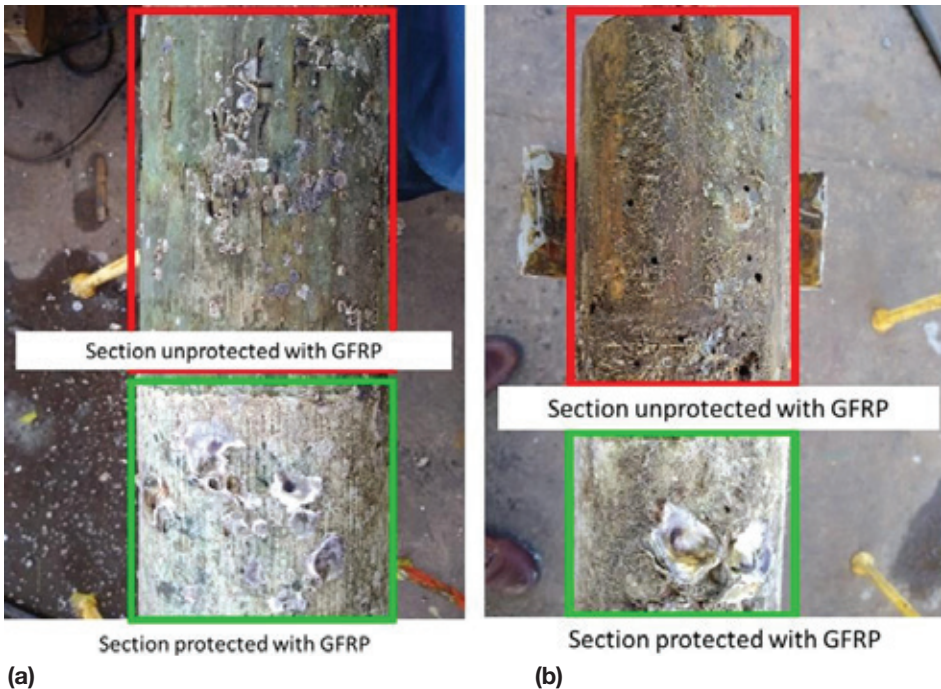
Figure 7: Conditions of the (a) treated and (b) untreated piling 2 years after submersion in the intracoastal

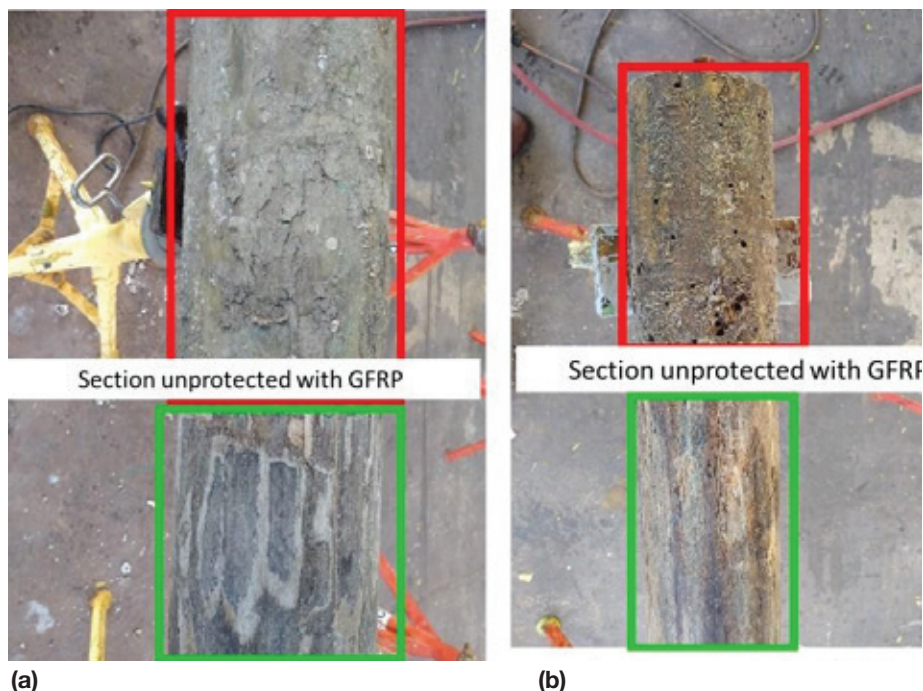
Figure 8: Conditions of the (a) treated and (b) untreated piling 2 years after submersion in the intracoastal and removal of the GFRP wrap, showing how well the wrap protected the timber substrate
