# STEEL BRIDGE PILING REPAIRS

Using Underwater GFRP

**CASE STUDY**  
**Maraba PA,**  
**Brazil**

A section of the railway passes over the Tocantins River via Ponte Rio Tocantins Bridge in Maraba PA, Brazil. This 1.67-kilometer bridge with 147 underwater reinforced concrete steel-jacketed pilings is maintained by global mining company Vale. While the steel jackets were intended to be sacrificial and designed only to protect the concrete pilings, increased rail traffic due to mining production increases, coupled with extensive steel jacket corrosion, resulted in the necessity for the steel jackets to perform as structural elements. Therefore, to prevent further corrosion on the steel jackets, a coating system was needed to extend jacket design life. The pilings are 1.5-meters OD and approximately 4.5-meters long. Figure 1 shows an overhead view of the bridge with the white repaired pilings visible.

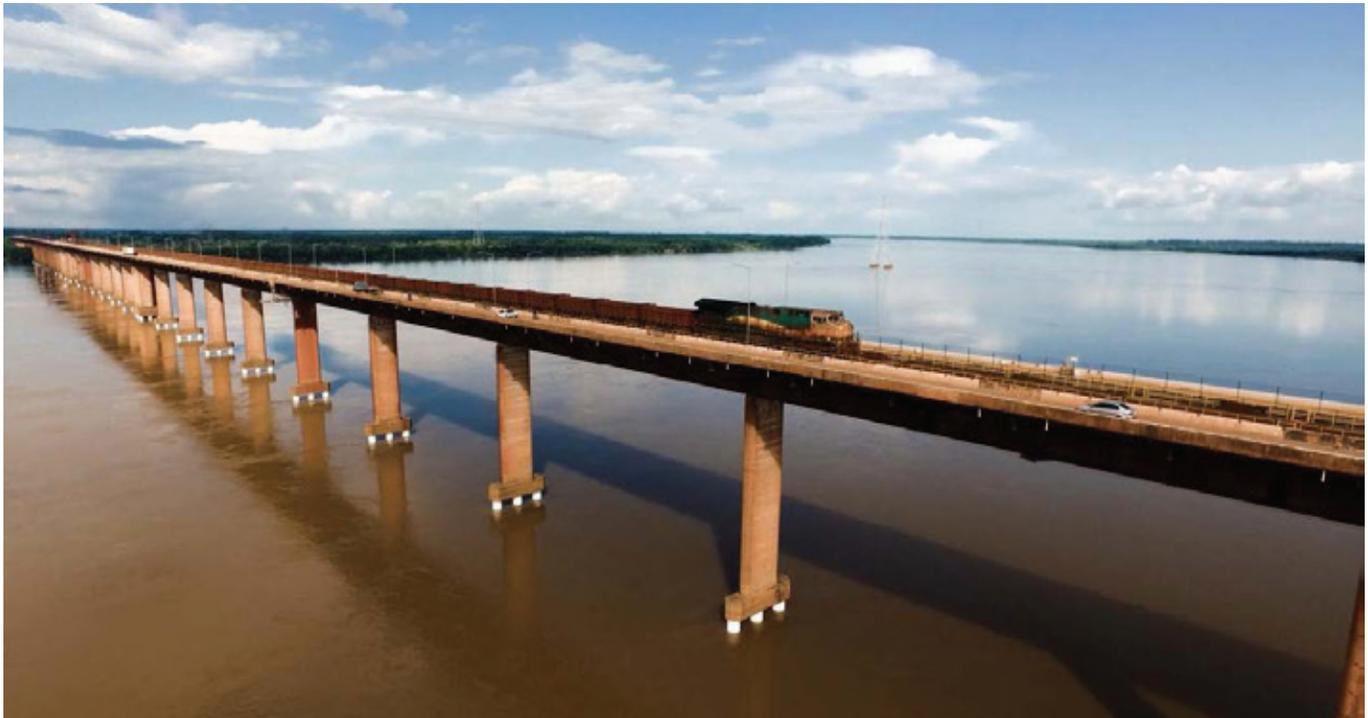
Figure 1: Overhead view of the bridge.

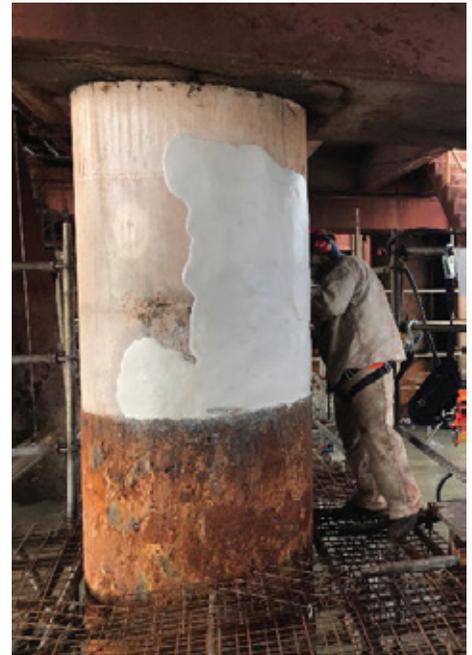
In addition, epoxy putty installation requires a larger mobilization, including a boat, a generator, a hydro-blaster, and 10 divers, and was estimated to take one day for each piling for the Tocantins project. Adding further complication, epoxy putty installation uniformity varies greatly based upon diver experience. Installed thickness, hand-applied, varies from diver to diver. Figure 2 shows an example of uneven epoxy installation.

Figure 2: Epoxy putty installation process.

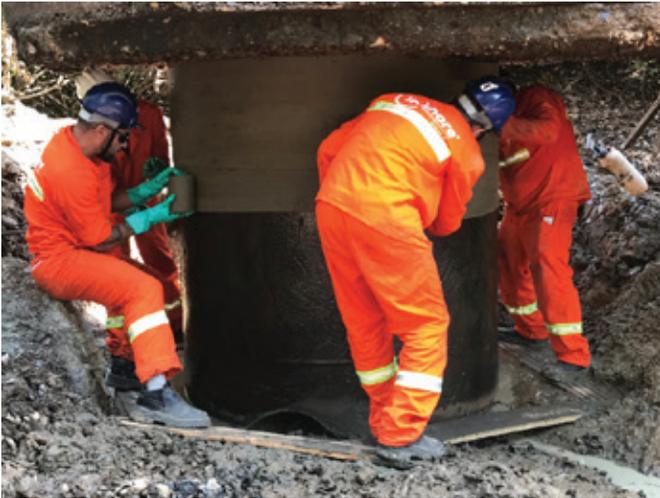
Figure 4: Application of the petrolatum primer and tape.

1. Application of the petrolatum primer and tape, as shown in Figure 4.
2. Installation of two layers of Syntho-Glass XT, spiraled around the perimeter of the piling with a 50% overlap, as shown in Figure 5.
3. Application of two layers of compression film, allowing the Syntho-Glass XT system to set for forty minutes, as shown in Figure 6.
4. Removal the compression film and installation of two layers of the Syntho-Glass SPF, as shown in Figure 7.
5. Application of two layers of compression film to allow the Syntho-Glass SPF system cure.

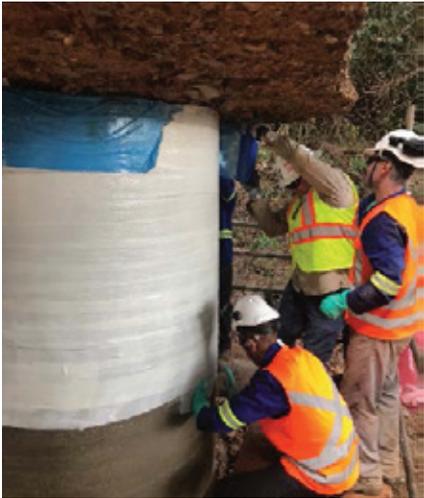
Figure 5: Application of two Syntho-Glass XT layers.

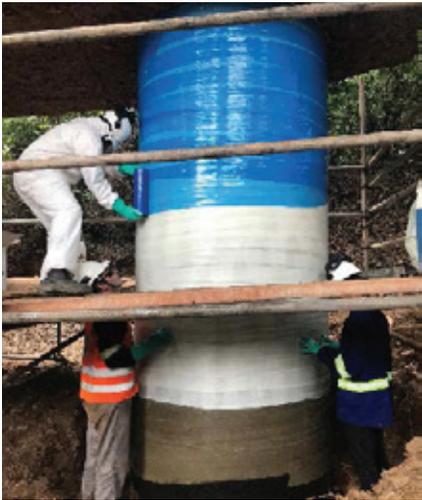
Figure 6: Application of compression film on top of the Syntho-Glass XT layers.

Steps 3 and 4 were necessary to avoid any bleeding of the petrolatum tap and XT resin into the UV coating system. This effect would have made the UV coating layers appear damaged and discolor overtime. In addition, at the termination of each 1.5-meter completed section, layers of the petrolatum tape and the composite layers were staggered with at least five cm to ten cm gap between. This would allow for the following sections to tie-in properly on the same piling. An example of the staggered layers of the different system can be seen in Figure 8 below. Finally, for piling areas that were not fully wrapped by an end of a workday, compression film was used to cover the exposed petrolatum tape sections.

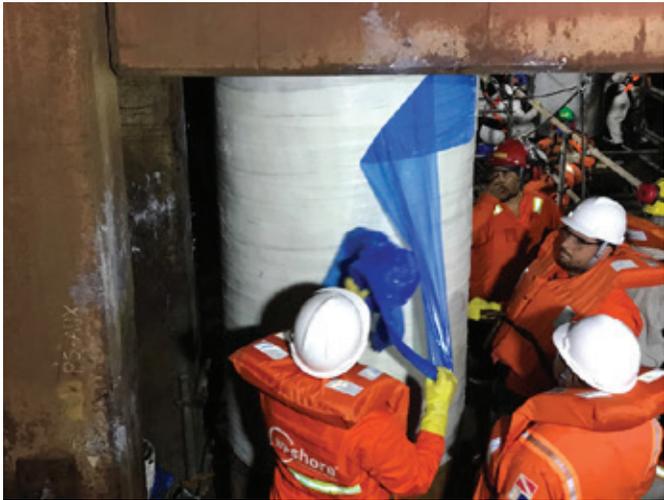
Figure 7: Removal of the compression film and installation of the Syntho-Glass SPF.

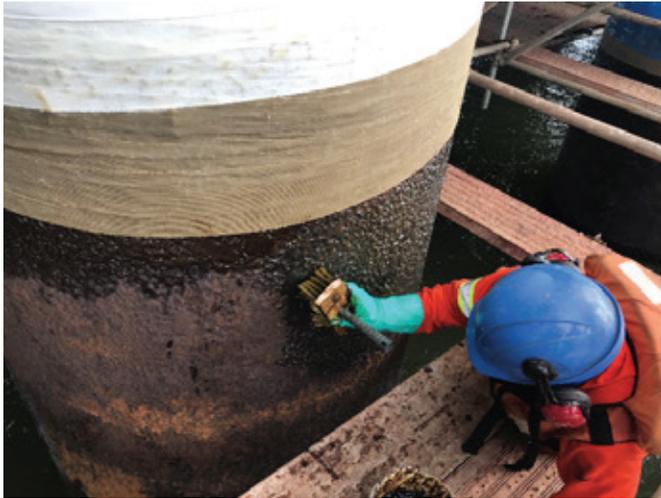
Figure 8: Staggered system layers on a repaired section and beginning of the installation of the next repair section.

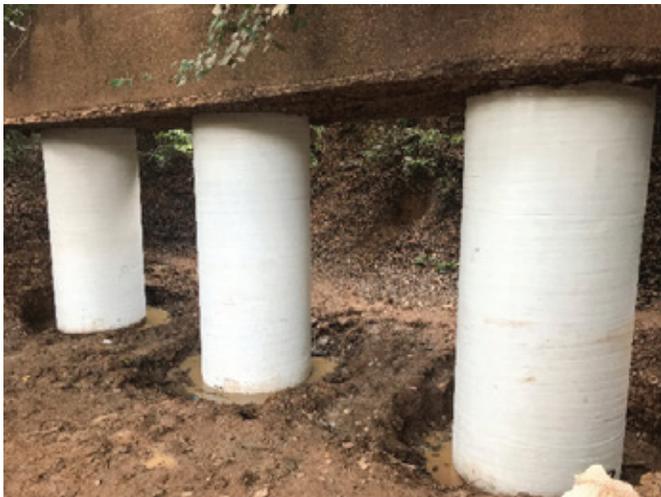
Figure 9: Pictures of the completed work.

The Ponte Rio Tocantins project included wrapping 147 steel piles with Syntho-Shield system. This project included various challenges including high current conditions, difficult access to the pilings, and poor visibility underwater. Though the client had considered various solutions for corrosion protection of the steel piles, they ultimately decided to use Syntho-Shield. The project was executed successfully leaving the client and contractor very pleased with ease of application, installation productivity, repair uniformity, total lower effective cost, and small mobilization required. Based on this success, Vale has moved forward to using the same product to repair additional structures. Pictures of the finished wrapped piles are shown in Figure 9 below.
