RENEWWRAP®

CASE STUDY:

Greenville, SC

Column Repair

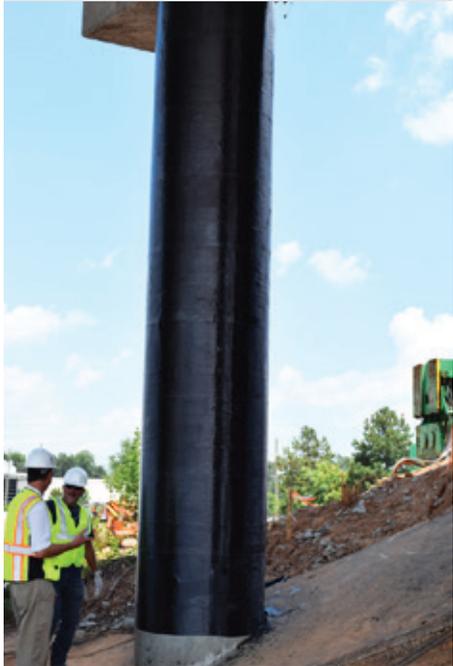
In June of 2016, the South Carolina DOT (SCDOT) was in the midst of building a new interchange at the intersection of I-85/I-385 in Greenville, South Carolina. During construction, severe localized spalling was found on the cover concrete of one column of a two-column pier supporting the I-385 northbound ramp. Upon discovery, the DOT and their consultant closed the ramp to all traffic until a detailed inspection could be made.

Post-repair inspection of all the columns and pier caps of the old interchange revealed various degrees of corrosion on the reinforcing steel, with the most severe occurring at construction joints. Cracks and small, localized delamination of sections of cover concrete were observed on many of the columns throughout the old interchange, including the column adjacent to the jacket-repaired column.

The RenewWrap system consists of high strength carbon fiber fabrics that are coated in the field with epoxy resins and bonded to or, in the case of the column repairs, wrapped around the structure to strengthen the member being repaired. The thousands of carbon fiber filaments in the FRP fabric perform the same function as reinforcing steel bars, but with the added advantage of being non-corrosive, which allows for placement directly on the surface of the columns.

Thanks to the minimal equipment requirements, the existing access area beneath the ramp was more than ample to perform the FRP installation. The crew cleaned the columns and patched small spalls to provide a uniform surface prior to installing the FRP.
