RENEWWRAP®

STRUCTURAL STRENGTHENING

CASE STUDY:

Central, CA Grain Silo

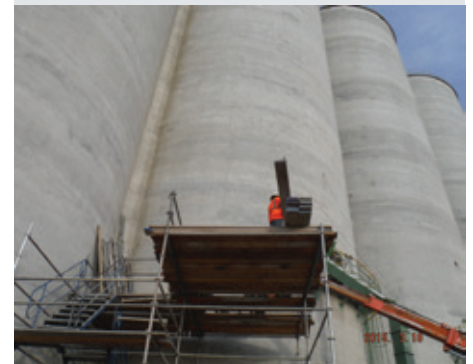
In 2014, a small section of one of the walls failed and collapsed into the interstice. Visual inspection that followed showed vertical cracking at various locations around the perimeter of three of the silos. The widest cracks were found on the inside face of the silo wall where it met the interstice wall. Combined hoop tension and negative moments occurred at this location.

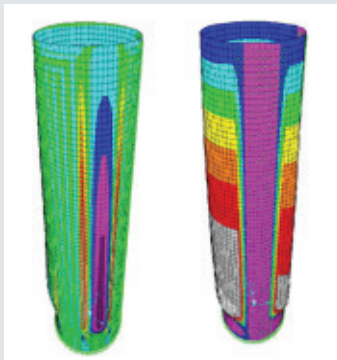
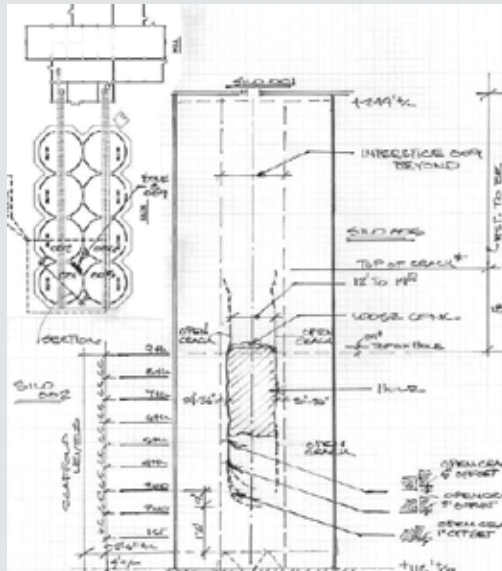
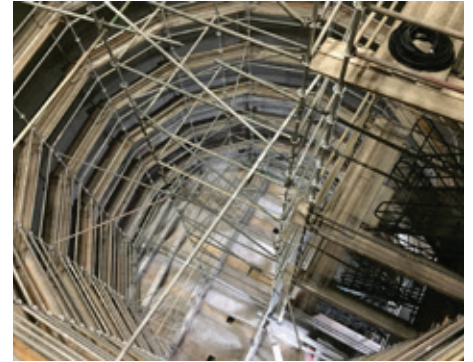
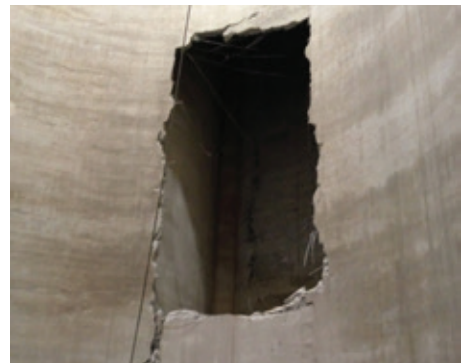
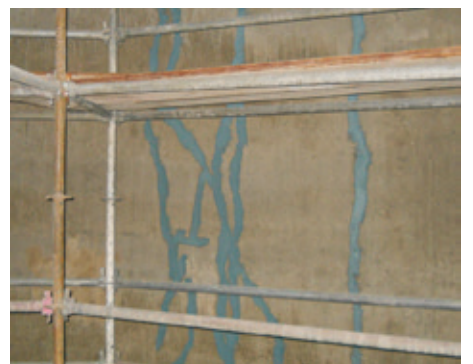
- ♦ The FRP specialty engineer worked closely with the owner's engineer to analyze the silos to determine the location and magnitude of the deficiencies.
- ♦ Finite element models were used to analyze multiple load cases including the impact of partially filling the interstices for stability in an attempt to optimize and reduce the cost of the repairs.
- ♦ Locating the FRP on the exterior face of the walls was initially considered but eventually ruled out due to the challenges of maintaining continuity at the common walls between silos.
- ♦ After analyzing a number of approaches the design-build team proposed installing the RenewWrap ESR CF600 carbon fiber strengthening system to the interior face of the silo wall.

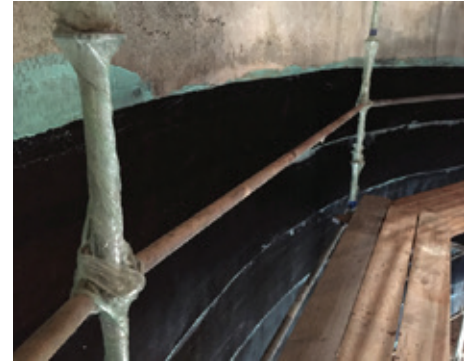
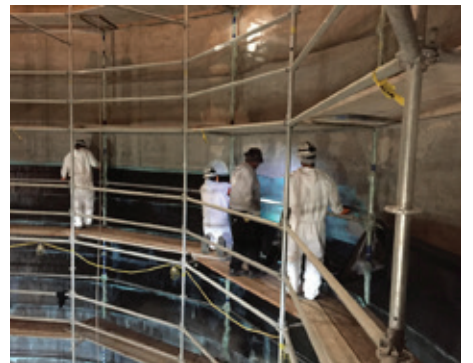
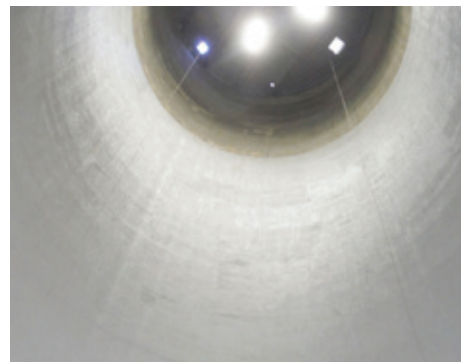
- ◆ Once the owner approved the proposal, scaffolding was quickly erected inside the silo to facilitate access to the entire wall surface area.
- ◆ The failed wall section was reconstructed using traditional cast-in-place techniques.
- ◆ Cracks were injected with epoxy and the walls pressure washed to prepare the surface of the concrete to receive the RenewWrap FRP system.
- ◆ Small mock-up sections were installed and tested for adhesion to verify adequate surface preparation.
- ◆ Two hoop plies of RenewWrap CF600 transitioning to one near the top of the wall and a vertical ply were bonded to the wall.
- ◆ The cured FRP system was coated with an abrasion resistant coating to protect the FRP during normal filling/unfilling operations of the silo.
- ◆ Additional stability was provided by partially filling the interstitial spaces with a controlled gravel infill.
